VEHICLE INSPECTION REPORT

ST10XJC

Ford Fiesta 1.4 TDCi Van

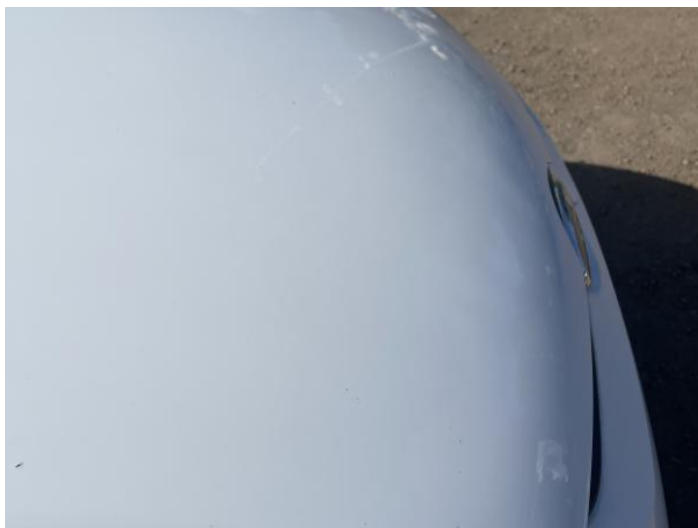
1: Bonnet
Dented
Over 30mm

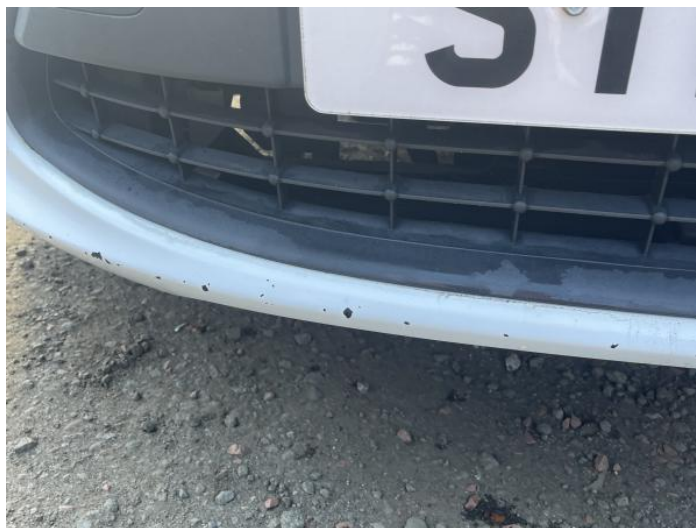
2: Bumper Front
Chipped
Multiple Chips

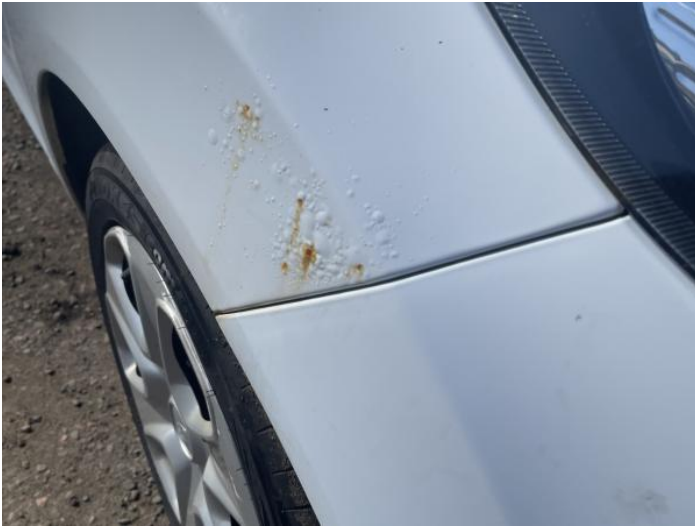
3: Wing osf
Rusted
Over 5mm

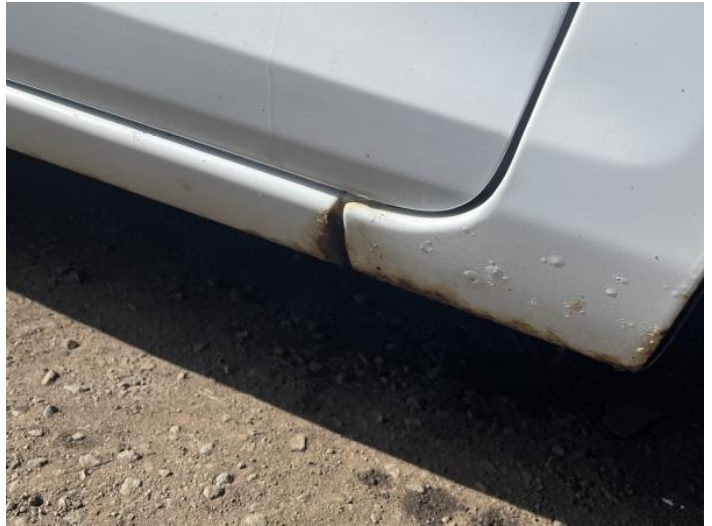
4: Sill os
Rusted
Over 5mm

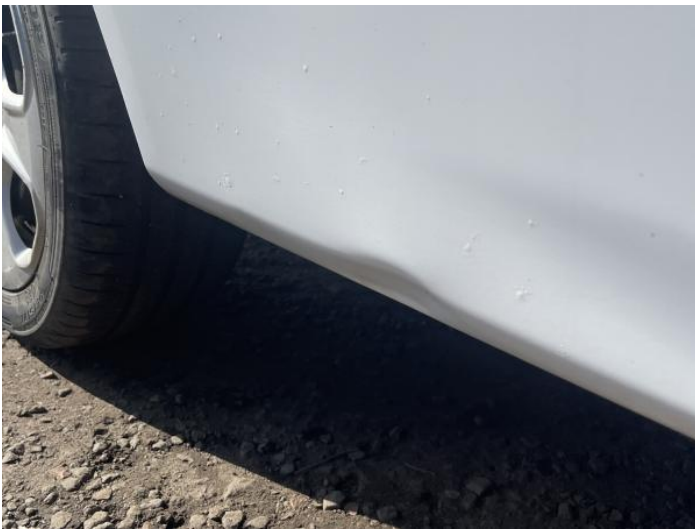
5: Qtr Panel osr
Dented
Over 30mm

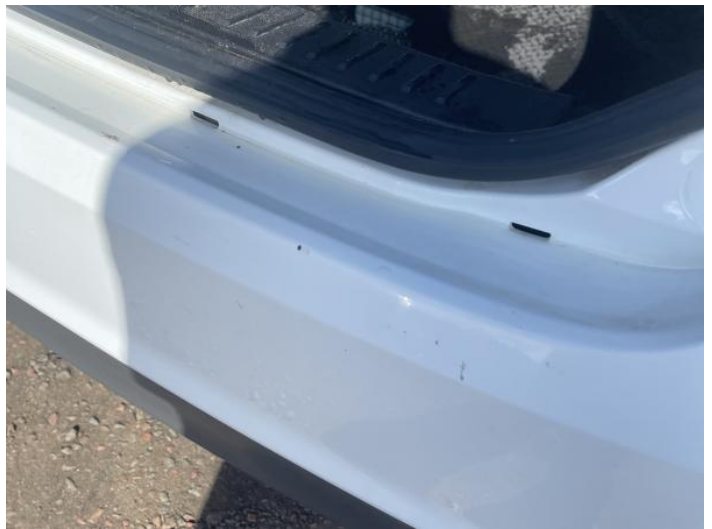
6: Bumper Rear
Dented
Over 30mm

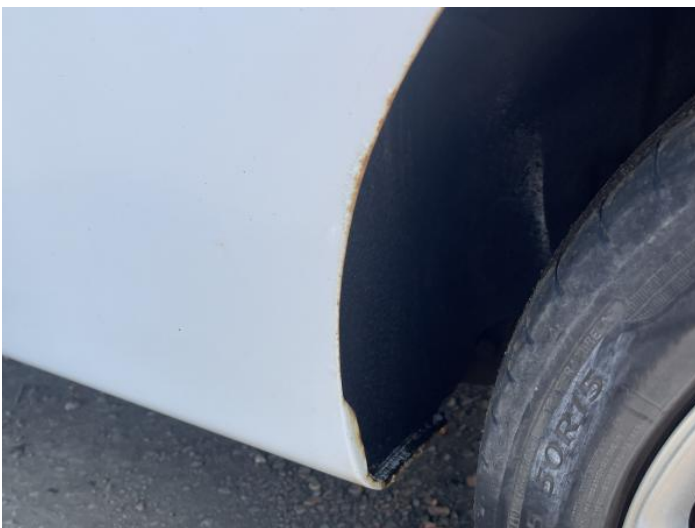
7: Qtr Panel nsr
Rusted
Over 5mm

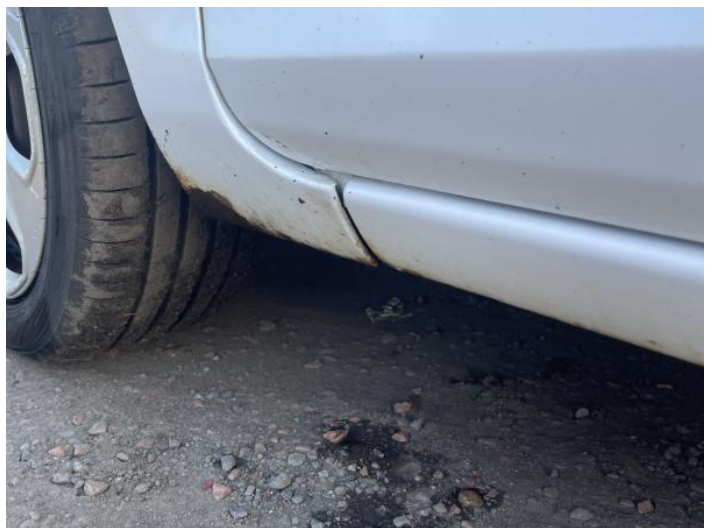
8: Sill ns
Rusted
Over 5mm

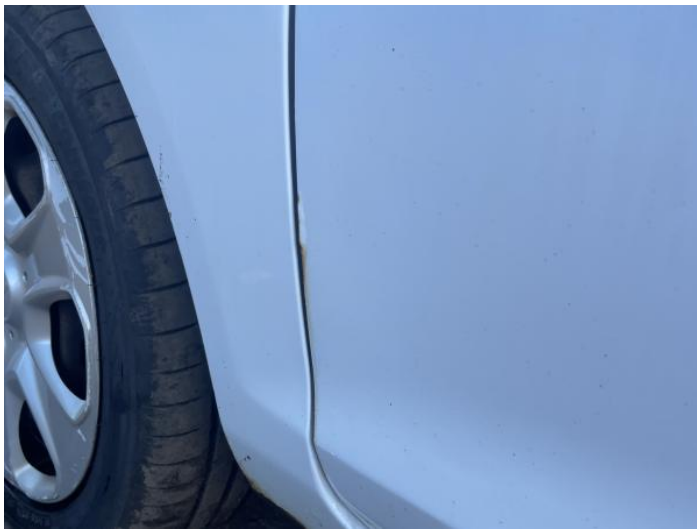
9: Door nsf
Rusted
UpTo 5mm

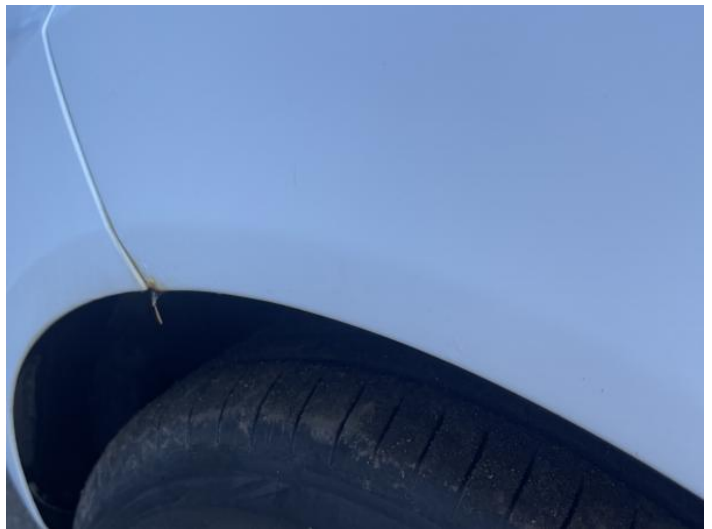
10: Wing nsf
Rusted
Over 5mm
